Existing Conditions Report

Borough of Bergenfield Municipal Building
198 North Washington Avenue, Bergenfield, NJ

Prepared by
RSC Architects

May, 2017

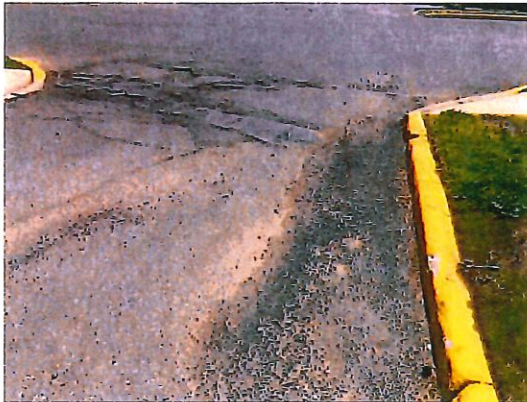
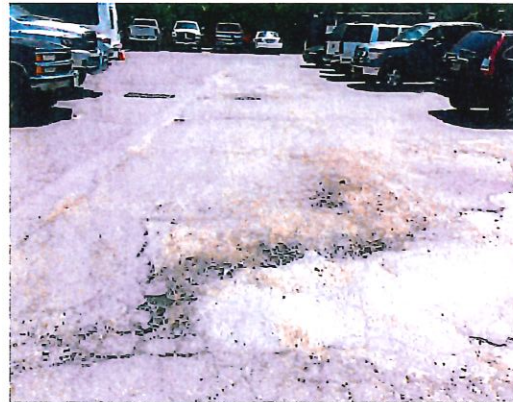
- b. **Asphalt Paving and Parking**–The overall asphalt paving is in poor to fair condition exhibiting the fact that the pavement has reached the end of its useful life. There are many areas exhibiting signs of “alligatoring” and linear cracking as well as fully disintegrated pavement and minor depressions that appear to hold water (*Figures 50 and 52*). The pavement should be completely repaired by milling and paving and include fully reconstructing the disintegrated substrate areas. The new pavement should then be restriped.

- c. **Concrete Curbs and Sidewalks** – The concrete curbing is in poor condition with abundant examples of chipped and missing sections of curbing and is in need of complete replacement.

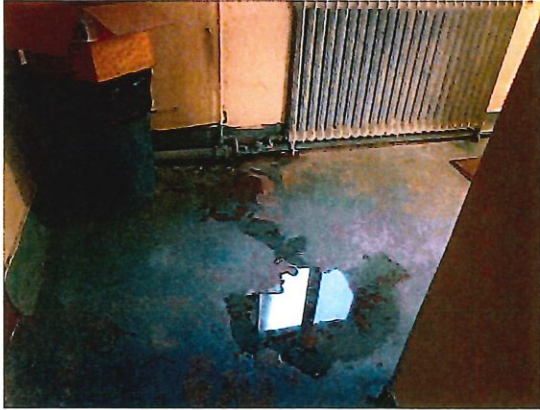
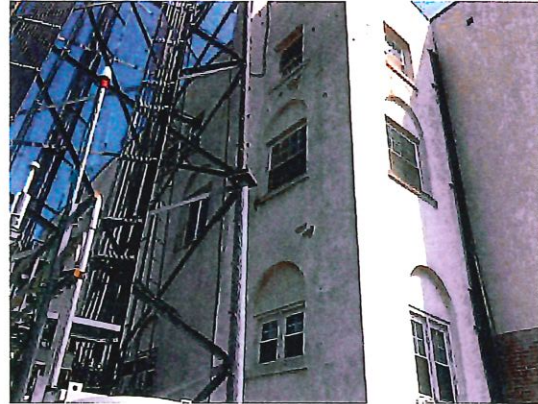
All of the stucco on the side and rear facades, and the stonework at the front façade have been coated with a masonry type paint and it is in failing condition with many peeling and spalling areas. DPW personnel indicate this coating is about 20 years old, and as such, is at the end of its useful service life, and should be restored with a new stucco coating.

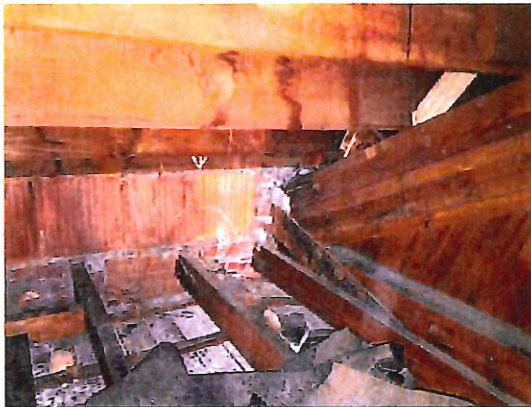
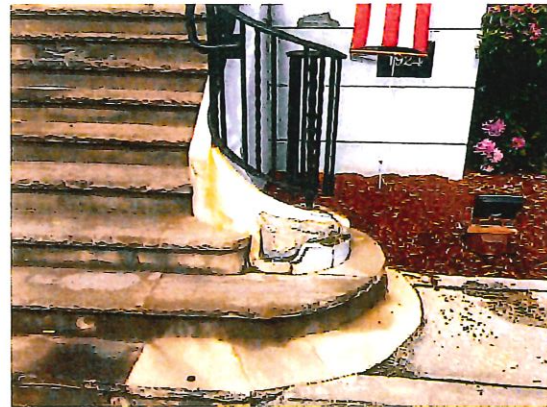
- c. **Entrance Portico** – The exterior entrance portico shows signs of more serious deterioration. The stone around the steps and the base is cracking and spalling in a number of places. Some of these stones have been repaired, but the repairs are also failing. There is spalling stucco at the bottom of the entablature spanning over the front steps, and the exposed steel lintel is badly rusted. Wrought iron railings have peeling paint, and are rusting. There is also a large crack through the center of the slab at the porch at the top of the stairs; this crack is visible inside the storage room below the porch, and runs across the entire width of the porch. The entire portico is in need of a restoration including filling the crack in the floor which extends to the interior, restoring the deteriorated stonework, replacing the steel lintel, repairing stucco, recoating the stucco surfaces, and repainting the stair railings.

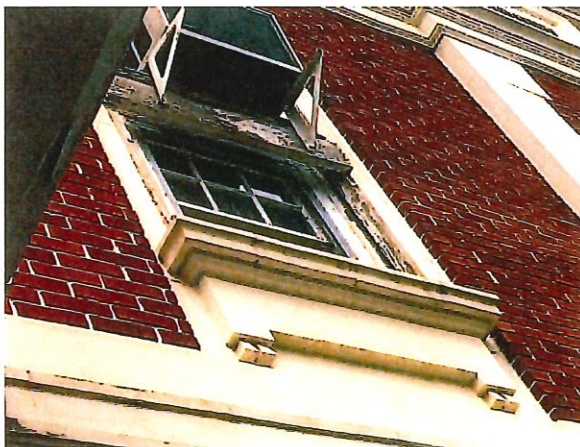
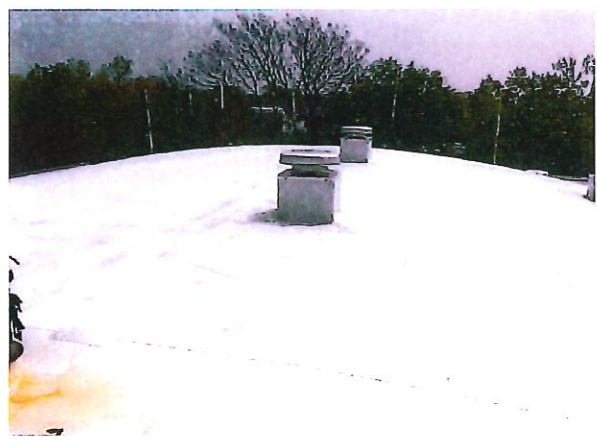
- e. **Windows and Glazing** – The windows throughout are typically in poor condition. From observations it appears that all of the original windows were wood, but have been subsequently been repaired with a combination of steel sash projecting windows (awning or casements) or aluminum double hung sashes; in most locations, however, the original wood head, jamb, and sill framing, and some of the larger mullions, still remain. Generally throughout, these frame members have peeling paint, are exposed to exterior moisture, and show signs of significant deterioration. Furthermore, all of the steel sash windows are only single glazed. Some of these show signs of deteriorating putty. Even the new steel frame windows at the back entrance / elevator enclosure are only single glazed, although these appear to be in good condition. Due to the poor condition and single-pane glazing, the windows would require complete replacement throughout the building.

- f. **Roofing** – The roof has recently been replaced with a white reflective TPO membrane. While this does appear to be in nearly new condition, during our site visit there was a leak observed at the roof drain in the NE corner of the building. The cause of this leak should be further investigated and corrected. Inspection of the underside of the roof from the attic

- g. **Exterior Fire Escape** – There is an exterior fire escape at the North side of the building which appears to be in structurally stable condition, however, the entire structure is peeling and the metal is rusting. As discussed later in this report, this structure should be removed and replaced with an enclosed stairway.
